INTRODUCTION

The pulp & paper plant discussed in this case study processes millions of pounds of paper. The concrete flooring slabs and support structures in the plant are exposed to a tremendous amount of impact and live loads due to transportation of material and vibration. As the concrete structure breaks down, cracks are exposed to various chemicals used in the manufacturing process, which corrode and deteriorate the reinforcing steel rebar.

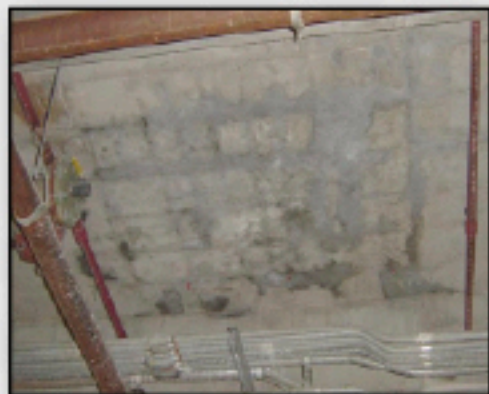
The overhead slab repaired in this case study was initially damaged from the topside by the impact of 5,000 lb rolls of paper that were dropped on its surface. The impact resulted in cracking of the concrete, which propagated under continued loading and vibration. The damage was accelerated by high heat and extreme humidity which created moisture that corroded the steel rebar within the slab. The alternative repair method considered involved
