INTRODUCTION

The Nuclear Generating Station included in this case study uses 90 MGD of treated municipal wastewater to cool its nuclear reactor. The wastewater travels through 36.4 miles of underground pre-stressed concrete cylinder pipe (PCCP), called the Water Reclamation Supply System Pipeline (WRSSP), with pipe diameters ranging from 96" diameter pipe to 114" diameter pipe. The PCCP segments are constructed of a 16 gauge steel shell protected by 0.162" diameter pre-stressing wire wrapped around the exterior concrete core and protected with a cement mortar coating.

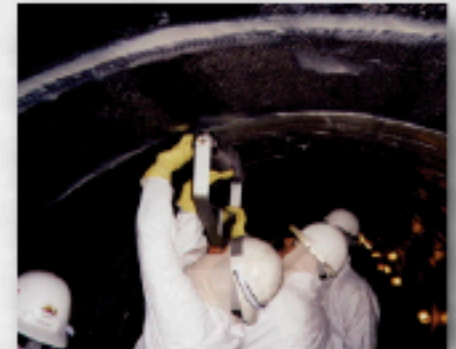
Active Corrosion of the existing steel reinforcement was detected throughout the WRSSP. Analysis of corroded areas showed that significant degradation had occurred and continued corrosion could result in loss of capacity and failure. Both carbon fiber and steel were initially considered to repair the WRSSP.

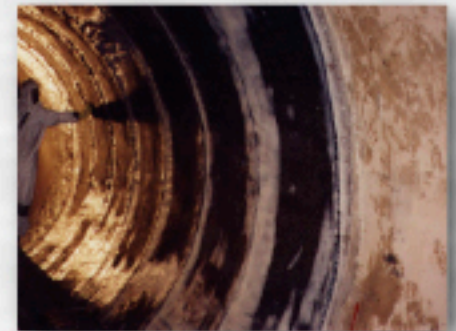
The owners created a test chamber to house and pressurize a 10-foot long by 96 inch PCCP pipe segment wrapped either internally or externally with carbon fiber. The pipe segment was capped with 1 inch steel bulkheads secured with thirteen 2-inch diameter steel rods through the pipe. The tested pipes were intentionally damaged allowing pressure to be fully carried by the carbon fiber-epoxy composite. The result of these tests showed that no leakage or structural distress was observed in the composite, which was subject to test pressures of up to 150 psi (equivalent of over one million pounds of force on the steel bulkheads), well in excess of system operating pressures.
