**Foundation  
Technologies, Inc.®**

Pulp and Paper plants utilize large steel high density tanks to store pulp. In this particular pulp and paper facility, a steel tank that stands 100 feet tall and 50 feet in diameter experienced significant corrosion resulting in over 900 through holes.

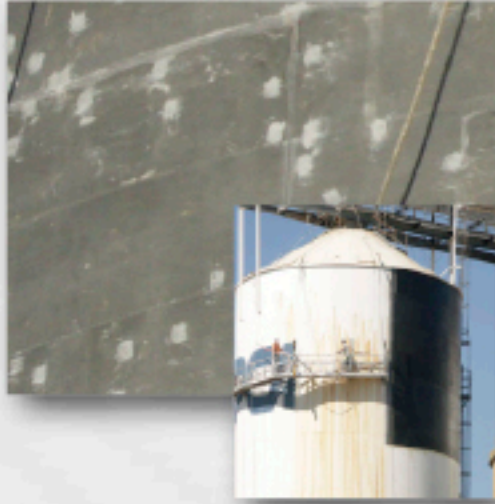
To determine the extent of corrosion, HJ3 performed an ultrasonic thickness test to measure the steel loss throughout the body of the tank. Corrosion to the steel ranged from 30% to 50% steel loss on the upper 50% of the steel tank only.
