## Internal Lining of Man Holes with Carbon Fiber and 120 mil top coat

### Case Study – HJ3 CS200914EN

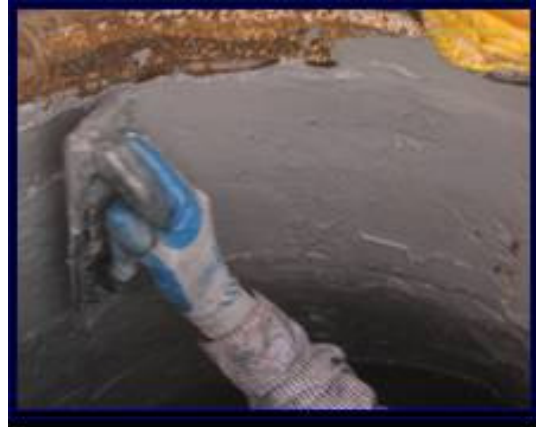
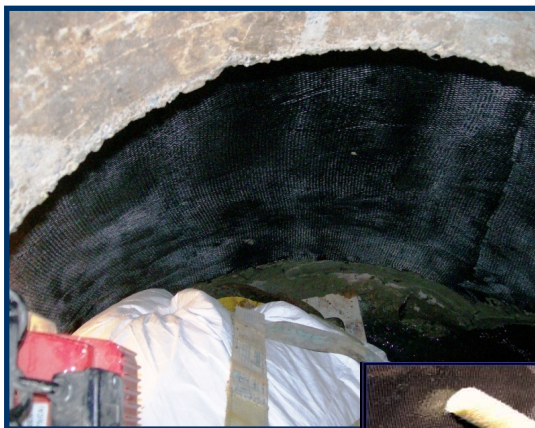
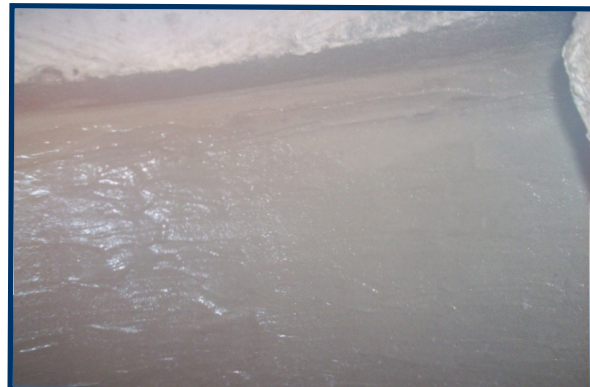
Hydrogen Sulfide from the waste that is processed through the sewer lines can attack the concrete surface of the manholes causing significant corrosion, cracking, and delamination of concrete. In addition, manholes experience structural failure caused by external forces such as hydrostatic pressure and soil heaving. In this particular case study, 30 manholes were repaired to mitigate the damages caused by corrosion and external soil pressure.

HJ3 engineers designed a repair that included one layer of CF-512 to provide internal surface tension to resist external soil pressures. The carbon fiber also served to chemically protect the manhole against hydrogen sulfide degradation. The system was installed during the presence of significant moisture and moisture tolerant grouts and primers were used to prepare the substrate. The repairs were completed in 30 days and created a 25% cost savings over standard 120 mil coating systems traditionally used for these repairs. Bond adhesion testing was performed for quality control 90 days after installation and showed a minimum of 300-psi bond strength to the substrate was achieved.
