Foundation Technologies, Inc.®

INTRODUCTION

The Refinery discussed in this case study processes a wide variety of petroleum products. Reinforced concrete columns and beams support extensive process piping throughout the plant. Overtime, exposure to the freeze thaw cycle and vibration caused extensive cracking of the concrete columns, delamination of the concrete and corrosion of the reinforcing steel rebar, causing OSHA to tag the columns.

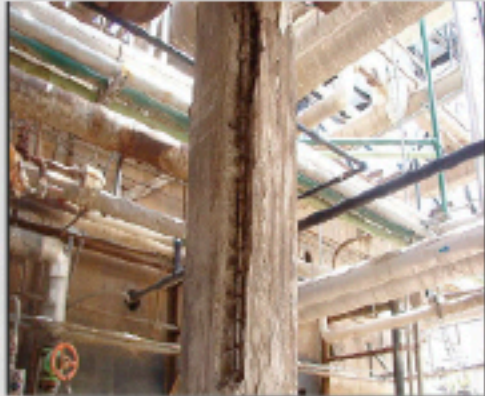
During a plant survey it was shown that reinforcing rebar within the column had deteriorated up to 25% as much of the rebar was completely exposed to the external environment. The resulting damage of the columns and beams compromised the structure's fire rating, endangering plant operations and worker safety. Given the extent of the damage, the plant considered three alternatives: replacement, resurfacing of concrete and

reinforcement with HJ3's Composite System, and only resurfacing the concrete. The plant chose to resurface the structures with a cement based grout to reestablish the fire rating of the structure and then strengthened the patched area with HJ3's Composite System. The use of HJ3's Composite System was selected to handle shear forces from thermal expansion and contraction and continued vibration that caused the initial damage to the columns.
