**Foundation Technologies, Inc.®**

The Copper Mine discussed in this case study utilizes an electrowinning process to extract high end copper from iron-ore. The electrolyte that is used to extract the copper is highly corrosive and acidic. Over 260 electrolytic tanks that hold the electrolyte are supported by concrete beams and columns in the basement of the SX/EW plant. The columns are reinforced with #6 steel bar spaced 12-inch on center around the circumference of the column.

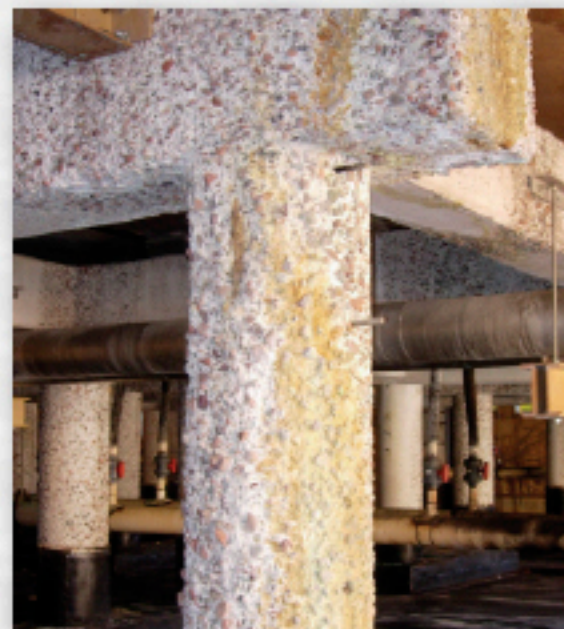
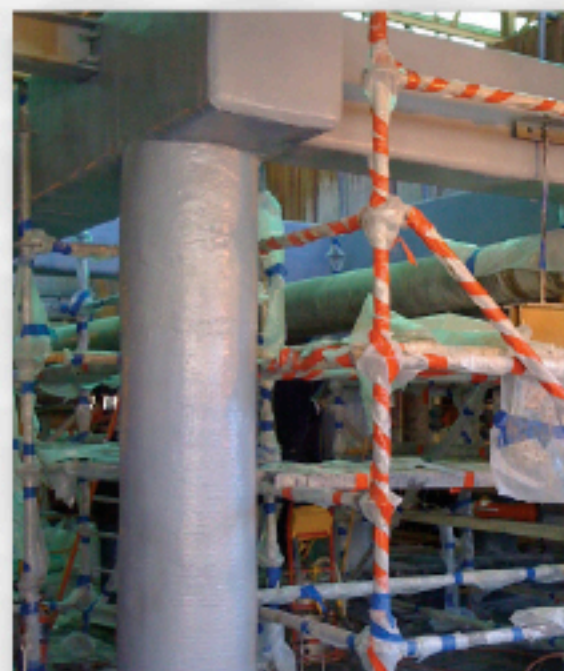
During a plant survey, extensive corrosion to both reinforced concrete columns and beams was noted. The problem stems from electrolyte attack of steel re-bar. As the tanks overflow electrolyte floods the basement and pools at the base of the columns. The electrolyte also leaks through the floor of the tanks and pools in the concrete beams. Over time the steel reinforcement will lose 50% to 75% of its strength causing risk of structural failure. At this facility, the electrolyte penetrated deep within the pores of the concrete surface of both the columns and the beams.

The columns were first abrasive blasted to remove loose particles and clean the substrate down to rough aggregate to thoroughly clean all contaminants out of the concrete substrate. The steel rebar were also cleaned and treated to prevent further corrosion. Next, a quick set 6000-psi grout was used to resurface the columns back to their original shape. After surface preparation and patching, the columns were primed with 10 mils of the HJ3 PC-100 Primer Coat. Then one layer of HJ3's s-glass fabric was saturated with SR-400 Saturating Resin and wrapped around the columns. A final coat of HJ3 HCRC- 511 Epoxy Novolac was installed over the HJ3 reinforcing system.

In total over 20 columns and beams were repaired and strengthened with the HJ3 Composite System. The total installation resulted in 75% to 80% cost savings over the traditional steel and concrete repair. The main advantages of the HJ3 Carbon Composite System were as follows:
