### HJ3

## INTRODUCTION

Mines utilize large steel tanks to store water that is used in various plant processes. In this particular copper facility, a steel tank that holds 2.5 Million gallons of water suffers from severe corrosion to its steel shell resulting in fatigue, cracking, and leaks.

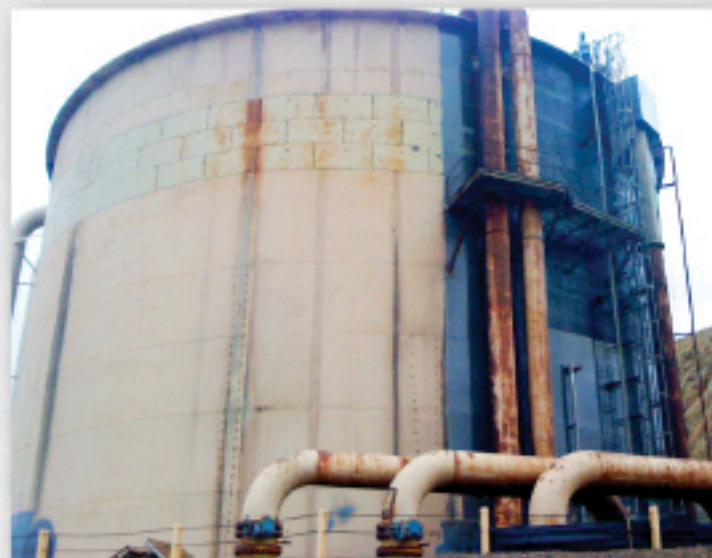
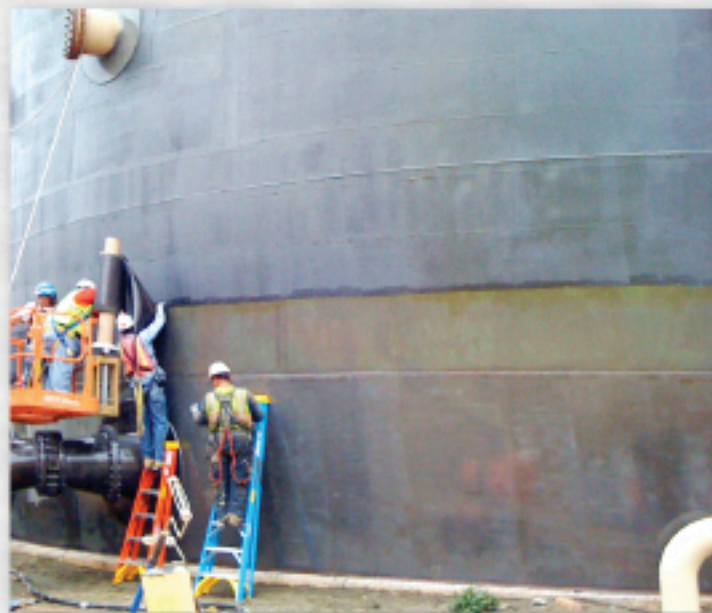
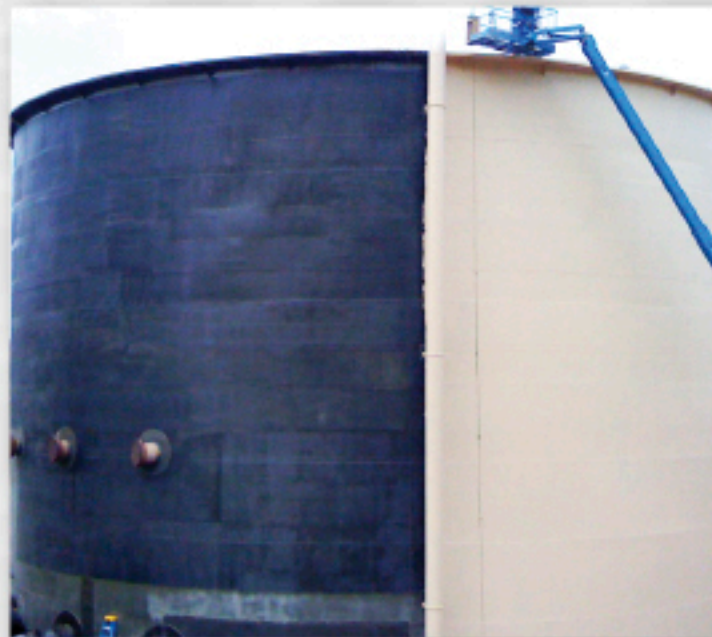
To determine the extent of corrosion, HJ3 performed an ultrasonic thickness test to measure the steel loss throughout the body of the tank. Corrosion to the steel ranged from 25% to 60% steel loss. At these levels, the existing steel was at risk of structural failure. To minimize risk of structural failure, the water levels within the tank were lowered to 50% capacity.

HJ3 engineers developed a carbon fiber solution layering carbon fiber to directly replace the strength lost for each ring of the tank. The bottom 50% of the steel tank was strengthened using one layer of HJ3 CF512 uni-directional fabric. The top 50% of the tank received anywhere from 2 layers to 4 layers of CF516 uni-directional carbon fiber. The system was then coated with a urethane top coat pigmented to match the company's colors and logos. The inside of the tank was blasted and coated to stop the internal corrosion from undermining the remaining steel.

The installation was completed in 8-weeks and resulted in over \$3 Million in savings when compared to a new steel tank. The HJ3 repair resulted in zero downtime and minimal interruptions to plant operations. The installed system was installed with a 3-year warranty that is standard on all HJ3 repairs.
