BEACH FRONT RESTAURANT SAVED FROM HURRICANE DENNIS

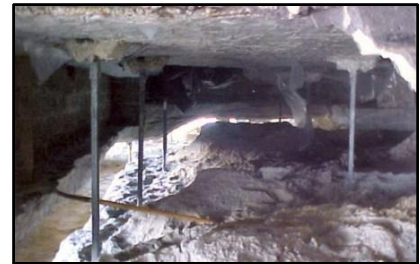
Fig.2.0

Hurricane Dennis came ashore just west of Destin the following year in July of 2005. Unfortunately for Captain Dave's, the entire restaurant was not supported by helical piles. The storm surge again undermined the footings and washed out the sand underneath the slabs. Where the building was supported on CHANCE® helical piles the footings and slabs were still intact, and where the building was not supported by helical piles the footings and slabs were destroyed. A backfilling and grouting operation is all that was required to occupy those portions of the building supported on helicals, where other portions had to be totally reconstructed.

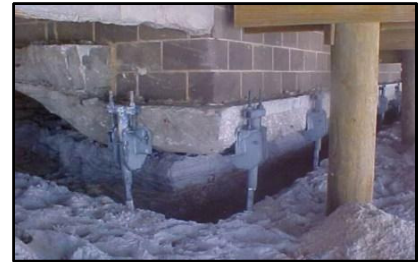
Fig.1.0

CHANCE® helical piles were chosen to underpin a portion of the building where existing footings were still intact and exposed. (Fig.1.0) Approximately 6'-7' vertical feet of sand was lost from the beach. The helical piles were also used for new construction piling in portions of the building where new slabs were to be poured on newly backfilled walls (Fig.2.0). The piles were able to be quickly installed with a mini-excavator from the beach side of the building in low overhead and difficult access locations. Noise and vibration concerns for nearby structures that had also sustained storm damage were eliminated by using helical screw piles. CHANCE® helical piles helped get portions of the restaurant structurally sound allowing the restaurant to resume business.
